Orlando Home Inspection Services

CONFIDENTIAL INSPECTION REPORT

INSPECTION ADDRESS: 123 Main Street, Apopka FL 32712

INSPECTION DATE: 01/01/2099

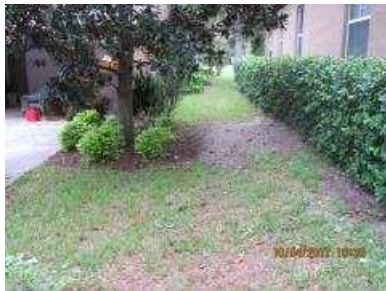
SITUS-YARD: The yard surrounding the property was in poor condition. Many bare areas and brown patches of lawn were visible. Soil erosion was noted on the right side of the home beneath the drip edge of the roof. Extensive maintenance is needed. I recommend that the yard be serviced by a qualified landscape specialist. Bare patches in the yard need to be sodded to prevent muddy conditions when it rains.

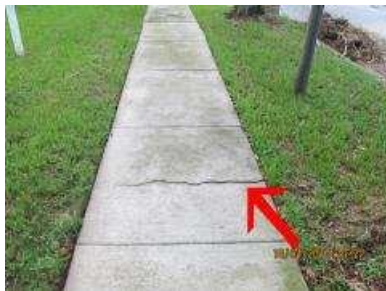
SIDEWALK: The sidewalk was damaged. A trip hazard condition exists. Recommendation: Since the principal cause of damage to driveways and sidewalks is tree roots I recommend that you cutaway the surface roots and repair the paving. Repair by an appropriate person is recommended.

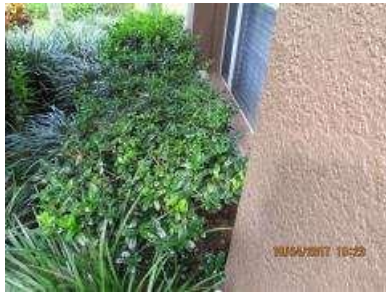
HEDGES: The hedges and general landscape vegetation needs to be maintained. Hedges should be kept trimmed at least 12-18 inches from the exterior siding to prevent moisture from accumulating in the area. Ongoing maintenance should be expected.

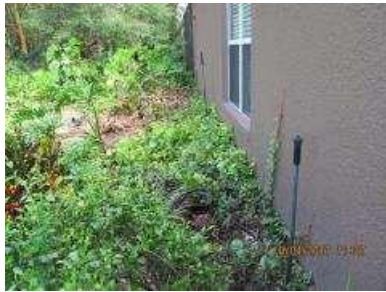
SHRUBBERY: The shrubbery, left side of the home was overgrown. It needs to be maintained. Ideally, it should be kept trimmed be at least six inches from the exterior siding so that moisture does not accumulate in the area.

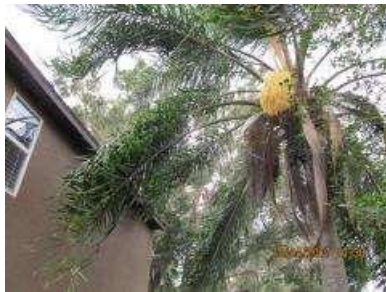
TREE BRANCHES: Tree branches are overhanging the roof. To protect the roof's surface against damage by abrasion, we recommend that the branches be trimmed so that they do not cause injury or rub on the roof's surface. This is an ongoing maintenance item.

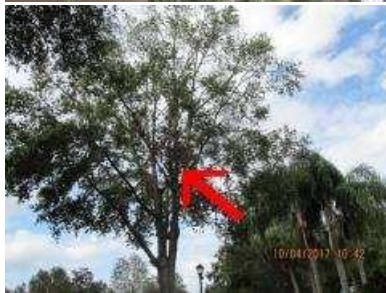
TREE BRANCHES: Dead branches were seen on the large tree at the front of the home. We recommend that they be removed before they fall and hurt someone.

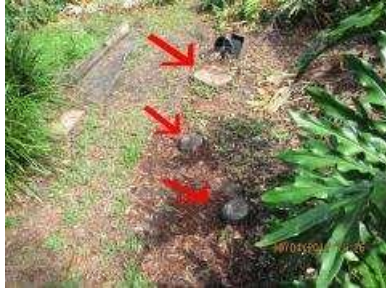
1. TREE ROOTS: Tree roots protruding above ground left and right of the property are potential trip hazards. We recommend that they be removed or ground-down to restore to a safe condition.

TREE ROOTS: Tree roots protruding above ground left and right of the property are potential trip hazards. We recommend that they be removed or ground-down to restore to a safe condition.

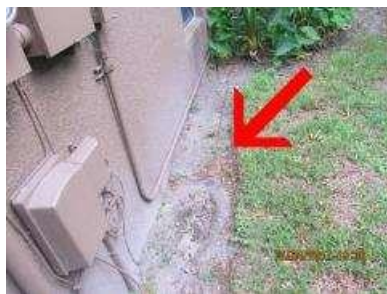
DRIP EDGE SOIL EROSION: On the right side of the property the dirt beneath the drip edge was being eroded by the rain water run-off. . This is because the yard was bare and the home does not have a gutter downspout system installed to redirect rain water run-off away from the foundation. To preserve your home's exterior siding and foundation, you must ensure that dirt, dense vegetation, mulch or anything the can hold moisture against your home is properly cleared away. Therefore, I recommend that a drip strip be installed. What is a drip strip? See next comment.

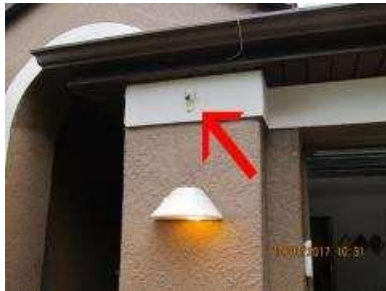
FLAG POLE HOLDER: Replace broken flag pole holder, at the front of the home.

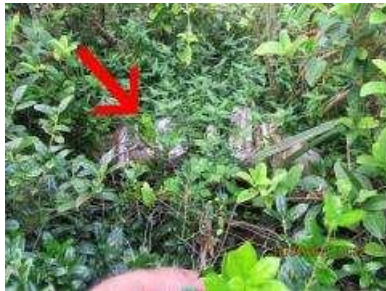
CITY PLUMBING: Left front of the home, sidewalk area, there is, hidden in the bushes, a large (4-inh) pipe that appeared to be connected to city's plumbing.

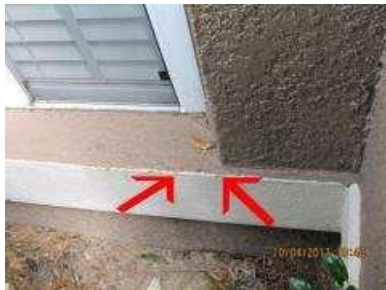
2. STUCCO DEFECT: The metal corner bead on the stucco, right front window area, is rusting. Repair as needed to restore proper function and appearance.

STUCCO DEFECT: The metal corner bead on the stucco, right front window area, is rusting. Repair as needed to restore proper function and appearance.

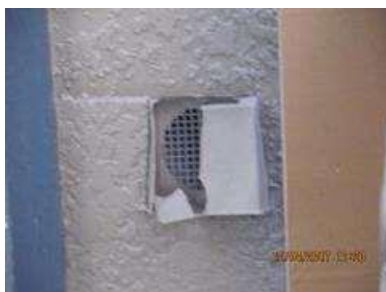
3. VENT FINDINGS: The protective cover - for an exhaust vent that appears to be fore the fireplace - is broken. Repair as needed.

VENT FINDINGS: The protective cover - for an exhaust vent that appears to be for the fireplace - is broken. Repair as needed.

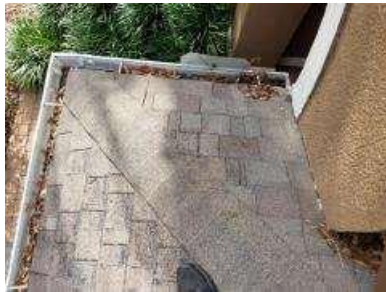
GUTTERS: SYSTEM CLOGGED: Leaves have accumulated in the gutters. Over time, the gutters will begin to deteriorate if they are not kept clean. Clogged gutters can cause permanent damage to your home's roof and siding. The inspector recommends that the gutters be cleaned regularly.

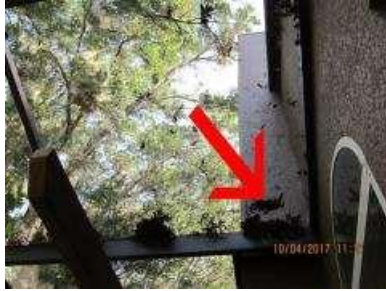
4. SCREEN PANELS: One or more of the screen panels were damaged. Repair to restore proper function and appearance.

SCREEN PANELS: One or more of the screen panels were damaged. Repair to restore proper function and appearance.

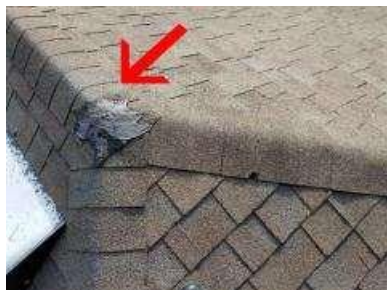
ROOF SHINGLES: MONITOR FOR LEAKS: Sections of the roof surface have been sealed with roof cement. When it rains, we recommend that you monitor these areas for leaks, and repair if needed. See also, photo 170058.

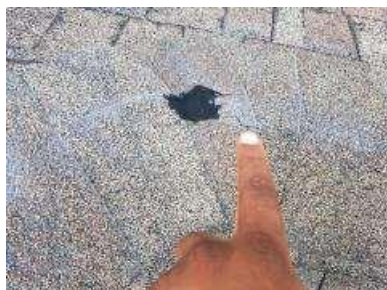
5. ROOF SHINGLES: The roof covering/surface was damaged in one or more areas. See also, photos 170233, 454, and 030. I recommend further review, repair, and/or replacement by a licensed roofer or other qualified person.

ROOF SHINGLES: The roof covering/surface was damaged in one or more areas. See also, photos 170233, 454, and 030. I recommend further review, repair, and/or replacement by a licensed roofer or other qualified person.

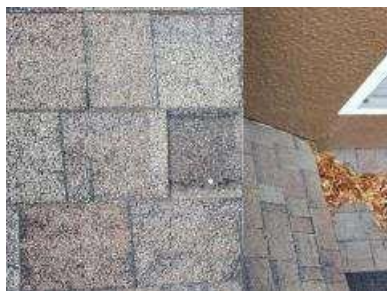
EXPOSED NAILS: I saw a few exposed nail near the area of the roof's surface where the shingles had been replaced. The nails need to be sealed with an appropriate sealant and the area needs to be monitored for leaks. See also - photos 165841 and 851.

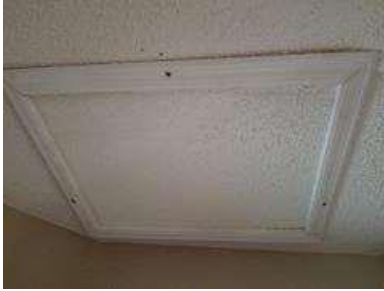
6. ACCESS PANEL-2nd FLOOR: The attic access panel on the 2nd was secured to the ceiling with screws. Usually, the access panel sits in a wooden frame that is created around the attic access hole so that the panel could be easily removed and replaced. The screws make it difficult to remove the panel.

ACCESS PANEL-2nd FLOOR: The attic access panel on the 2nd was secured to the ceiling with screws. Usually, the access panel sits in a wooden frame that is created around the attic access hole so that the panel could be easily removed and replaced. The screws make it difficult to remove the panel.

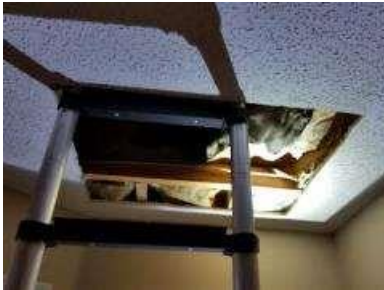
ACCESS PANEL-2nd FLOOR: Also, the rough framed opening for the attic access on the 2nd floor, floor appeared to be under-sized and badly positioned. The access opening must measure a minimum of 22 by 30 inches and the opening is usually freely accessed. In this case, there is a 2 x 4 stud that reduces the size of the opening. .

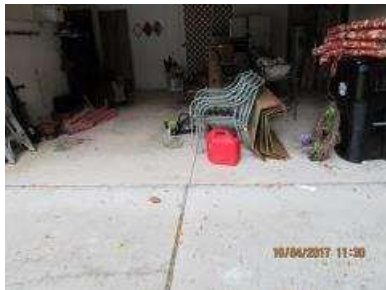
GARAGE CLUTTER: The interior of the garage was cluttered. The inspection was limited to those areas that were visible and accessible. Recommendation: Reinspect hidden areas as soon as it is possible to do so.

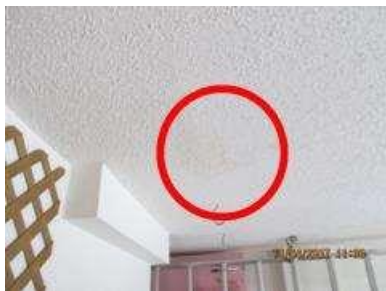
GARAGE CEILING: Two areas of the garage ceiling exhibited evidence of water leakage. The moisture meter showed no elevated levels of moisture in the ceiling materials at the time of the inspection, indicating that leakage has not been recent. The lack of elevated moisture content may be weather-related or may be an indication that the source of leakage has been corrected. You should ask the seller about this condition.

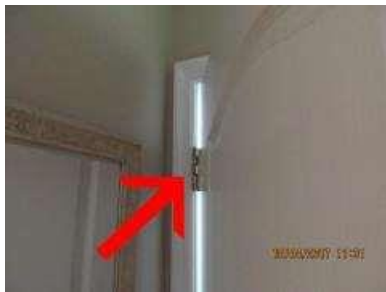
AUTOMATIC DOOR CLOSER: The entry door from the garage to the house was not equipped with a properly functioning automatic safety closer. Recommend installing a hinge pin door closer to restore the automatic closer function required for a one hour fire rated assembly.

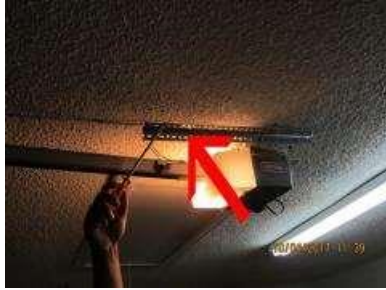
8. GARAGE DOOR MOTOR: The support brackets for the overhead motor for the garage door was loose. Repair as needed to restore to a safe condition.

GARAGE DOOR MOTOR: The support brackets for the overhead motor for the garage door was loose. Repair as needed to restore to a safe condition.

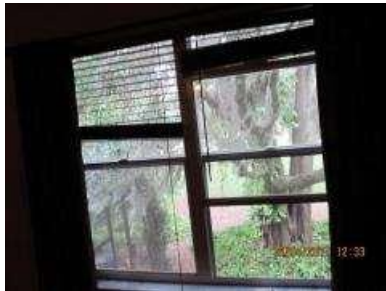
10. LOFT WINDOW: The hardware for the window in the loft area was defective. Repair or Replace as needed.

LOFT WINDOW: The hardware for the window in the loft area was defective. Repair or Replace as needed.

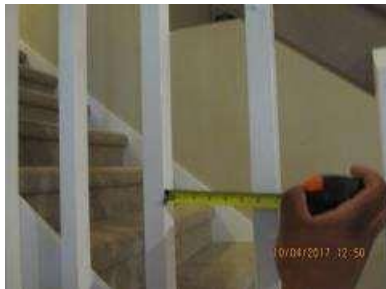
11. BALUSTER: **Safety Issue:** The spacing between two or more of the balusters was greater than 4". The inspector recommends the spacing between balusters be corrected in accordance with industry standards.

BALUSTER: Safety Issue: The spacing between two or more of the balusters was greater than 4". The inspector recommends the spacing between balusters be corrected in accordance with industry standards.

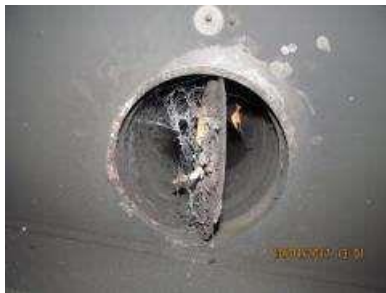
12. DAMPER: The flue damper was covered with cobwebs. We recommend that the fireplace be serviced by a professional chimney sweep before it is used. .

DAMPER: The flue damper was covered with cobwebs. We recommend that the fireplace be serviced by a professional chimney sweep before it is used. .

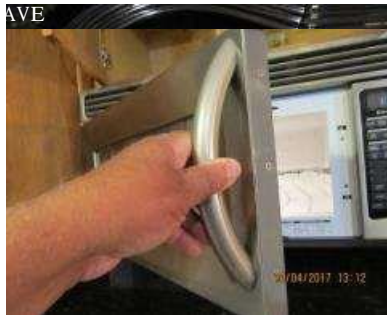
14. MICROWAVE: **Findings:** The door handle for the microwave was loose or broken. Repair or replace to restore proper function.

MICROWAVE: Findings: The door handle for the microwave was loose or broken. Repair or replace to restore proper function.

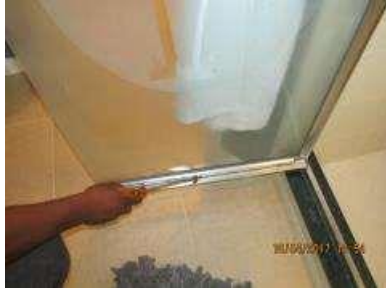
15. SHOWER DOOR: The base plate for the shower door in master bath is loose. Repair as needed to restore proper function.

SHOWER DOOR: The base plate for the shower door in master bath is loose. Repair as needed to restore proper function.

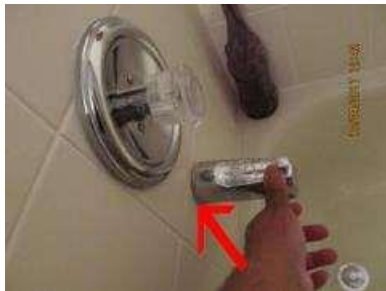
16. TUB SPOUT: The filler spout in this bathroom was loose in the wall. It needs to be caulked to prevent water intrusion behind the wall.

TUB SPOUT: The filler spout in this bathroom was loose in the wall. It needs to be caulked to prevent water intrusion behind the wall.

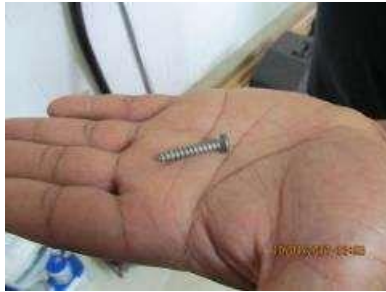
17. PANEL SCREWS: **Safety Concern:** The screws used to attach the dead front cover to the sub-panel were not designed for that purpose - they were too long and may contact or damage energized components inside the service panel. This condition is a potential shock/electrocution hazard. We recommend further evaluation, repair or replacement by an appropriate person.

PANEL SCREWS: Safety Concern: The screws used to attach the dead front cover to the sub-panel were not designed for that purpose - they were too long and may contact or damage energized components inside the service panel. This condition is a potential shock/electrocution hazard. We recommend further evaluation, repair or replacement by an appropriate person.

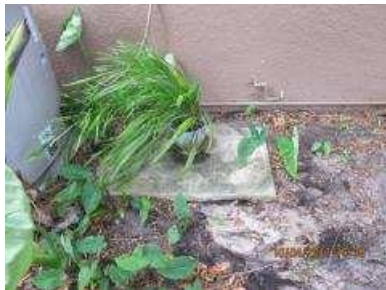
OBSERVATION: On the right side of the home, there are two (2) air-condition concrete pads. One was being used, the other was not. This suggest that when the home was constructed, the home probably had two (2) exterior units. The present system appeared to be a replacement system. So, it is possible that one of the units may have been taken out of service and a newer, (possibly larger) unit was installed. Further review by a qualified person is recommended.

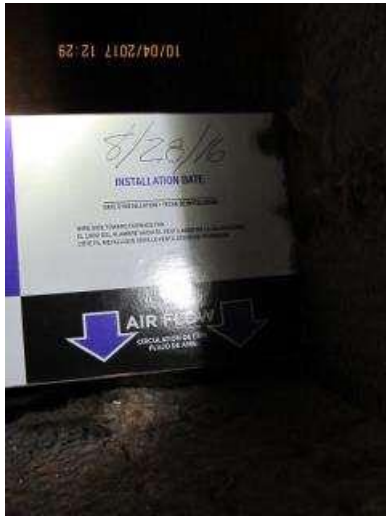
18. AIR FILTER FINDINGS: The installation date of the air filter was 8/28/2016. This info was hand-written on the filter. This means the filter is more than one year old. I recommend that it be replaced.

AIR FILTER FINDINGS: The installation date of the air filter was 8/28/2016. This info was hand-written on the filter. This means the filter is more than one year old. I recommend that it be replaced.

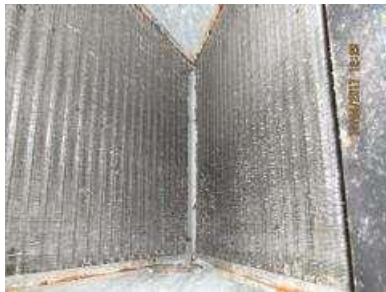
EVAPORATOR COIL: The evaporator coil was not as clean as it needs to be for the system to function properly. Dirty coils are usually caused by poor maintenance. The Inspector recommends that before the close of escrow, you have the entire HVAC system be serviced by a qualified HVAC technician.

to function properly. Dirty coils are usually caused by poor maintenance. The Inspector recommends that before the close of escrow, you have the entire HVAC system be serviced by a qualified HVAC technician.

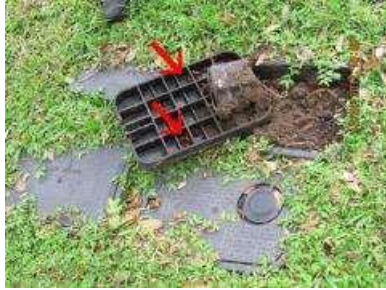
WATER METER: I was unsuccessful in my attempt to locate the water meter. I suspect that it may be buried under the dirt or ground cover. However, at the right of the driveway of the adjacent property (#873) , there are four (4) meter boxes visible. It is possible that one of them may be associated with the subject property. You may learn of the exact location of the water meter by calling the utility company.

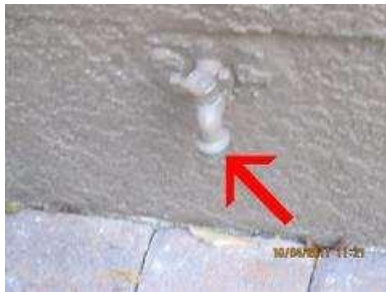
21. HOSEBIB(S): The hosebib at the home was not equipped with the required (HVB's) which is the anti-siphon device that is designed to protect the house water supply from contamination. Solution: To improve the margin of health safety, the inspector recommends installation an HVB on each exterior hosebib.

HOSEBIB(S): The hosebib at the home was not equipped with the required (HVB's) which is the anti-siphon device that is designed to protect the house water supply from contamination. Solution: To improve the margin of health safety, the inspector recommends installation an HVB on each exterior hosebib.

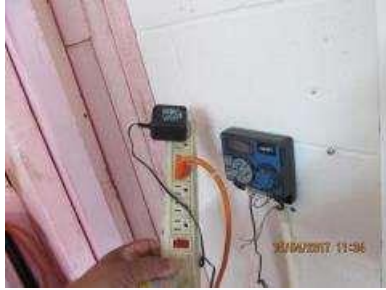
LAWN SPRINKLER SYSTEM: There was a lawn sprinkler system installed. It appeared to be defective. The wiring for the automatic sprinkler control was loose. Also, it was being powered by extension cord wiring. Testing the system is beyond the scope of this inspection. Recommend that the equipment be serviced by a professional.

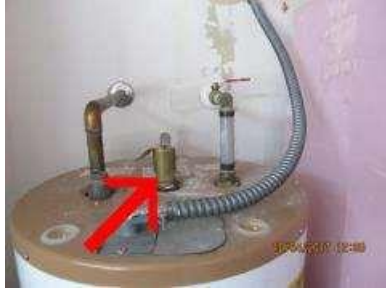
23. TPR VALVE: The temperature (TPR) pressure relief valve failed a functional test. It leaked after being tested. Repair by a qualified person is recommended.

TPR VALVE: The temperature (TPR) pressure relief valve failed a functional test. It leaked after being tested. Repair by a qualified person is recommended.

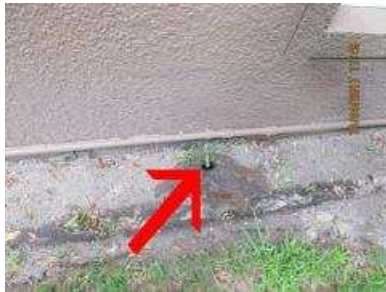
24. TPR OVERFLOW PIPE: The over flow or discharge pipe for the water heater was properly sized, and routed to an acceptable location. However, it appeared that the discharge pipe has a threaded end. This threaded end should be removed to eliminate the possibility of a cap being placed improperly on the pipe. Repair should be done by an appropriate person.

TPR OVERFLOW PIPE: The over flow or discharge pipe for the water heater was properly sized, and routed to an acceptable location. However, it appeared that the discharge pipe has a threaded end. This threaded end should be removed to eliminate the possibility of a cap being placed improperly on the pipe. Repair should be done by an appropriate person.

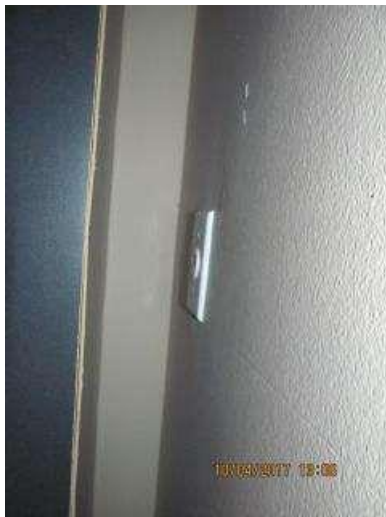
LAUNDRY ELECTRICAL - OUTLETS: The 120 volt outlet receptacle at the laundry area was not accessible and therefore not tested. Troubleshoot and repair as needed.
