Orlando Home Inspection Services

CONFIDENTIAL INSPECTION REPORT

INSPECTION ADDRESS: 123 Main Street, Apopka FL 32712

INSPECTION DATE: 01/01/2099

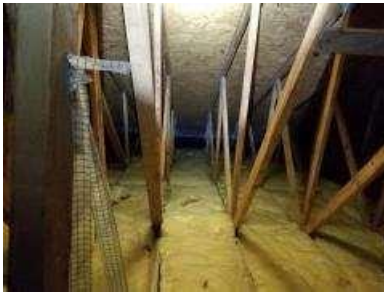
6. ACCESS PANEL-2nd FLOOR: The attic access panel on the 2nd was secured to the ceiling with screws. Usually, the access panel sits in a wooden frame that is created around the attic access hole so that the panel could be easily removed and replaced. The screws make it difficult to remove the panel.

ACCESS PANEL-2nd FLOOR: Also, the rough framed opening for the attic access on the 2nd floor, floor appeared to be under-sized and badly positioned. The access opening must measure a minimum of 22 by 30 inches and the opening is usually freely accessed. In this case, there is a 2 x 4 stud that reduces the size of the opening. .

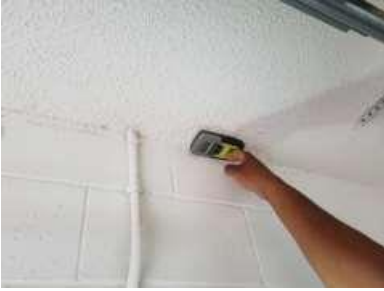
GARAGE CEILING: Two areas of the garage ceiling exhibited evidence of water leakage. The moisture meter showed no elevated levels of moisture in the ceiling materials at the time of the inspection, indicating that leakage has not been recent. The lack of elevated moisture content may be weather-related or may be an indication that the source of leakage has been corrected. You should ask the seller about this condition.

GARAGE CEILING: The moisture meter showed no elevated levels of moisture in the ceiling materials at the time of the inspection, indicating that leakage has not been recent.

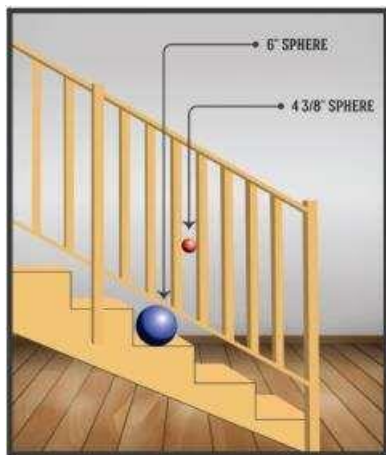
11. BALUSTER: **Safety Issue:** The spacing between two or more of the balusters was greater than 4". The inspector recommends the spacing between balusters be corrected in accordance with industry standards.

BALUSTER: Safety Issue: The spacing between two or more of the balusters was greater than 4". The inspector recommends the spacing between balusters be corrected in accordance with industry standards.

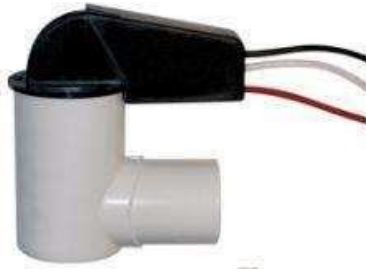
CONDENSATE SWITCH: I did not see a condensate drain line overflow low voltage float switch. When working properly, this switch will protect the equipment and the property by shutting down the unit if the condensate pipe ever becomes clogged. I recommend that one be installed.

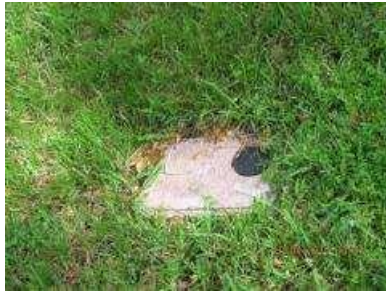
WATER METER: I was unsuccessful in my attempt to locate the water meter. I suspect that it may be buried under the dirt or ground cover. However, at the right of the driveway of the adjacent property (#873) , there are four (4) meter boxes visible. It is possible that one of them may be associated with the subject property. You may learn of the exact location of the water meter by calling the utility company.

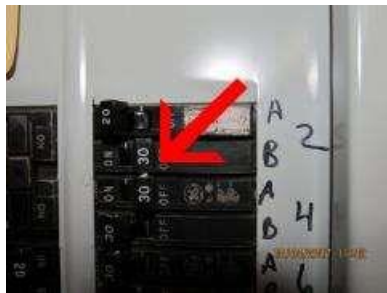
TYPE /FUNCTION: Power to the unit was turned-off at the circuit breaker in the main panel. Since turning circuit breakers goes beyond the scope of the inspection, the inspector was unable to tell if it would deliver hot water at the taps. To test if the unit is working, once the breaker is turned on you should receive hot water at the taps in 15-30 minutes.
